Subject: Onsite Wastewater Feasibility Study
Moccasin Flats Subdivision - 19 Lot Subdivision
Hurricane, Utah
AGEC Project Number: 2181805

MOCCASIN FLATS SUBDIVISION
HURRICANE, UTAH

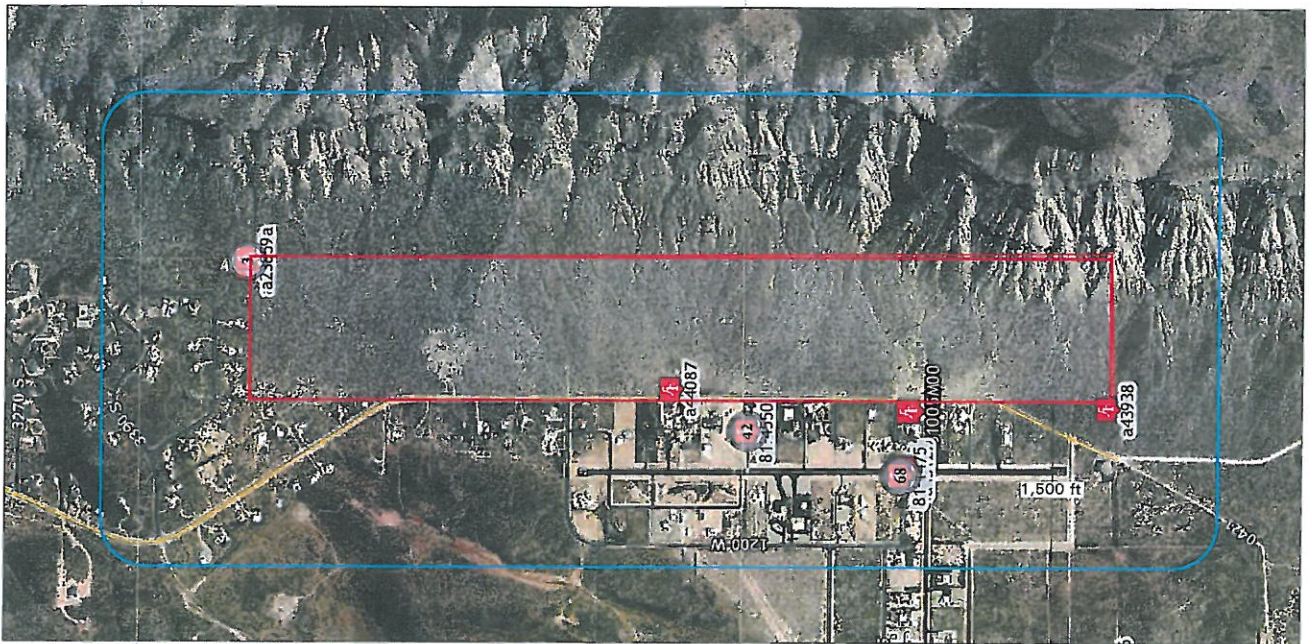
Figure 3

According to the Utah Division of Water Rights website, the site contains 8 underground water wells within 1,500 feet of the site (see Figure 3). Of the 8 well sites, 3 were drilled after 1992 and are therefore included in the permit database and are summarized in Table 1 below. Additional records for the other 5 older wells can be accessed at <http://maps.waterrights.utah.gov>. Based on the interactive map provided on the Utah Division of Water Rights website, only one of the wells is located on the site, with the other 7 wells located on adjacent land to north and west as shown on Figure 3.

Water Well Locations

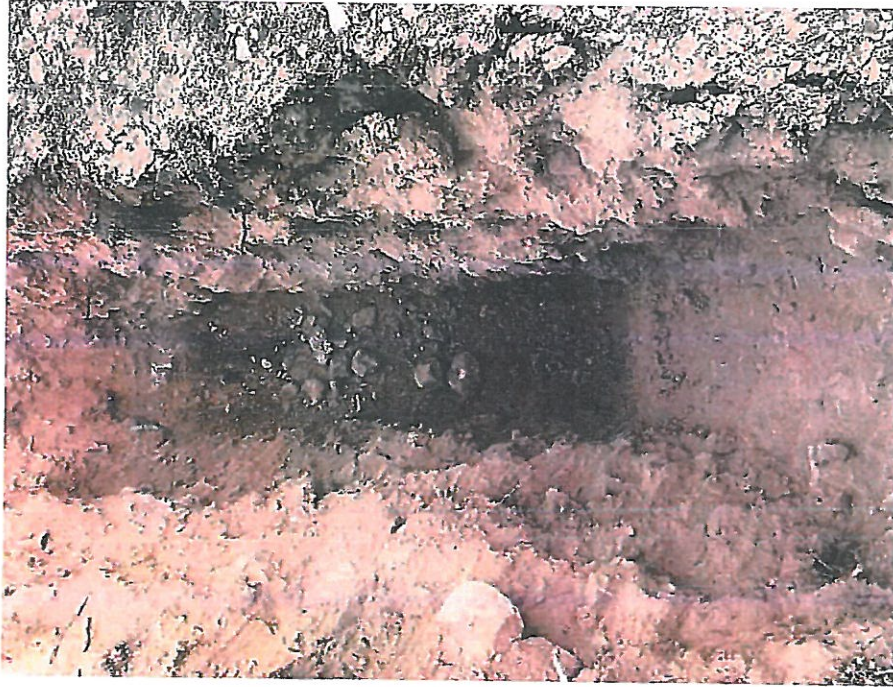
Photo 19: Test Pit TP-19

On October 15 and 16, 2018, a total of 19 test pits were excavated with a mini-excavator. The test pits were excavated to a minimum depth of 10 feet, except for test pit TP-19 where excavator refusal was encountered on large boulders at 7 feet below grade. The results of our field study indicate the subsurface conditions at the site generally consists of sandy loam with various amounts of gravel to the maximum depth investigated approximately 10 feet. Test pit logs for the corresponding percolation test results are attached on the percolation certificates.
